I-5:
Steamboat Slough and Union Slough Bridges

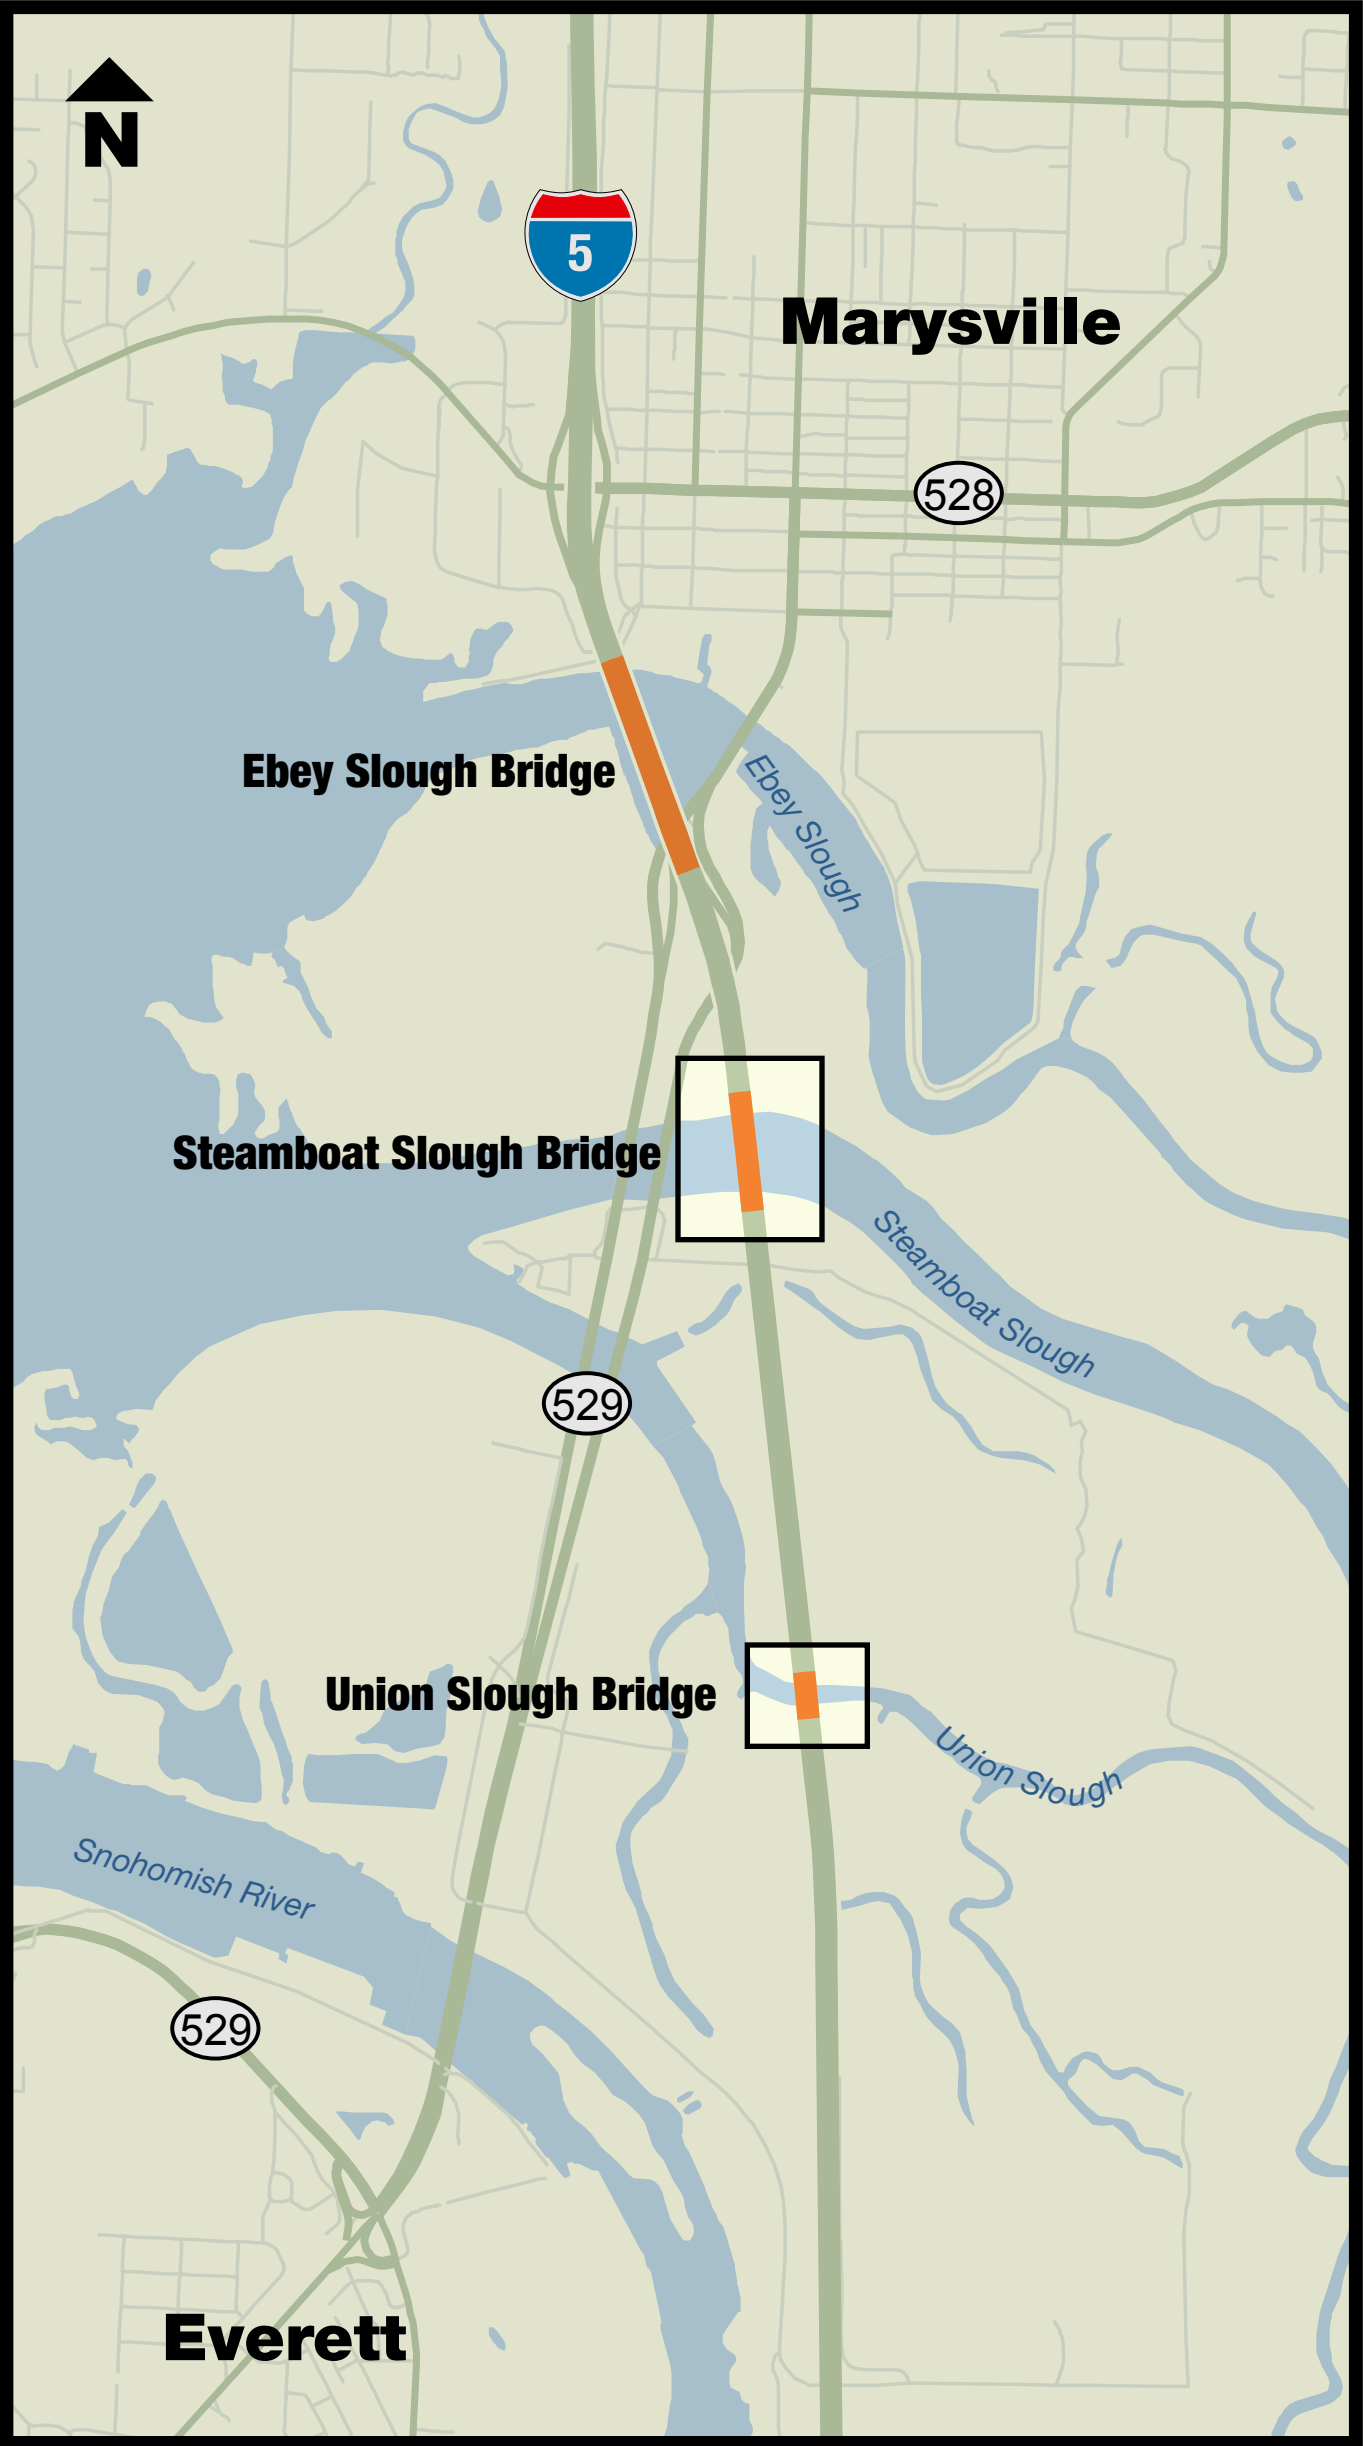
Steamboat Slough Bridge

Northbound bridge – 2 expansion joints

- Strip seal
- 20 years old
- 48 feet long

Southbound bridge – 2 expansion joints

Union Slough Bridge

Northbound bridge – 5 expansion joints

- Bolt down
- 30 years old
- 48 feet long

Southbound bridge – 5 expansion joints
